Manhole Inspection Summary

Manhole # S57CC_006MH

Inspection ☐ Is Incomplete Rating: **3) Fair**

Insp Date: **6/5/08 1:56 PM**

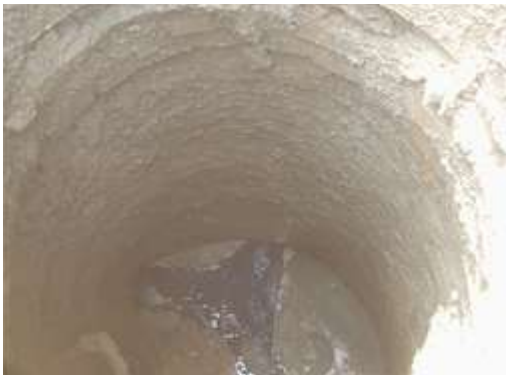
Defect 1

Infiltration

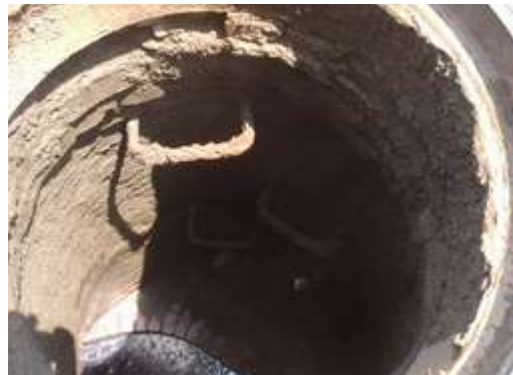
Defect 2

Infiltration

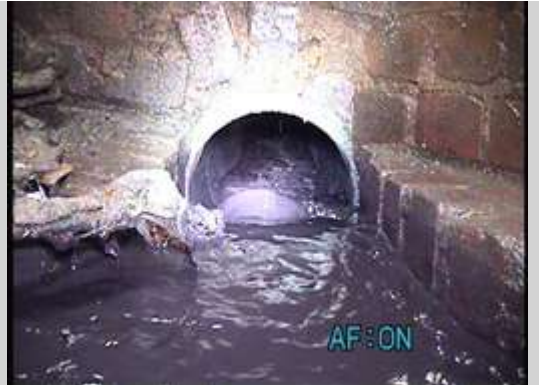
12 O'Clock Outflow

8 in. Circular Gravity Sewer
Pipe Out @ 12 O'Clock

Pipe Height: **8.4** (in.) Rod and Bar (Angled)
Pipe Material: **Clay** ☐ Pipe Lined
Invert Depth: **8.95** (ft.) Flow Characteristics: **Fast**
Deposits: ☒ None ☐ Mud ☐ Sludge ☐ Debris ☐ Grease
Silt Depth: (in.) Deposits Extent:
Infiltration: **None** Pipe Seal Cond: **Sound**

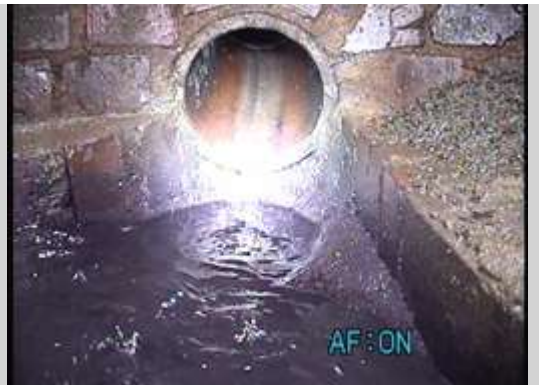
3 O'Clock Inflow

6 in. Circular Gravity Sewer
Pipe In @ 3 O'Clock

Pipe Height: **6** (in.) Rod and Bar (Angled)
Pipe Material: **Clay** ☐ Pipe Lined
Invert Depth: **8.45** (ft.) Flow Characteristics: **Fast**
Deposits: ☒ None ☐ Mud ☐ Sludge ☐ Debris ☐ Grease
Silt Depth: (in.) Deposits Extent:
Infiltration: **None** Pipe Seal Cond: **Sound**

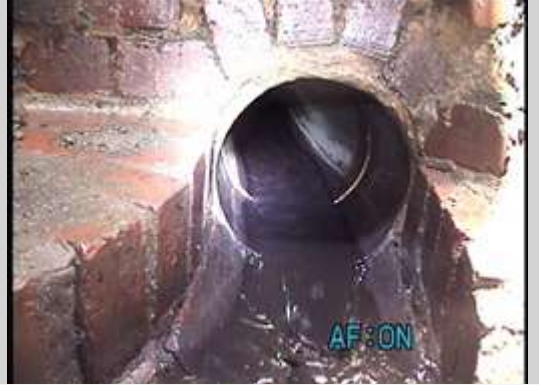
6 O'Clock Inflow

Infiltration: **None** Pipe Seal Cond: **Sound**
